**DEPARTMENT OF TRANSPORTATION****DIVISION OF ENGINEERING SERVICES**

Contract #: 04-0120F4Cty: SF/ALA Rte: 80 PM: 13.2/13.9File #: 99.28**WELDING INSPECTION REPORT****Resident Engineer:** Pursell, Gary**Address:** 333 Burma Road**City:** Oakland, CA 94607**Report No:** WIR-016197**Date Inspected:** 06-Aug-2010**Project Name:** SAS Superstructure**OSM Arrival Time:** 700**Prime Contractor:** American Bridge/Fluor Enterprises, a JV**OSM Departure Time:** 1900**Contractor:** Zhenhua Port Machinery Company, Ltd (ZPMC) Chanxing Island**Location:** Shanghai, China**CWI Name:** Mr. Geng Wei**CWI Present:** Yes No**Inspected CWI report:** Yes No N/A**Rod Oven in Use:** Yes No N/A**Electrode to specification:** Yes No N/A**Weld Procedures Followed:** Yes No N/A**Qualified Welders:** Yes No N/A**Verified Joint Fit-up:** Yes No N/A**Approved Drawings:** Yes No N/A**Approved WPS:** Yes No N/A**Delayed / Cancelled:** Yes No N/A**Bridge No:** 34-0006**Component:** OBG Segments**Summary of Items Observed:**

## WELDING INSPECTION REPORT

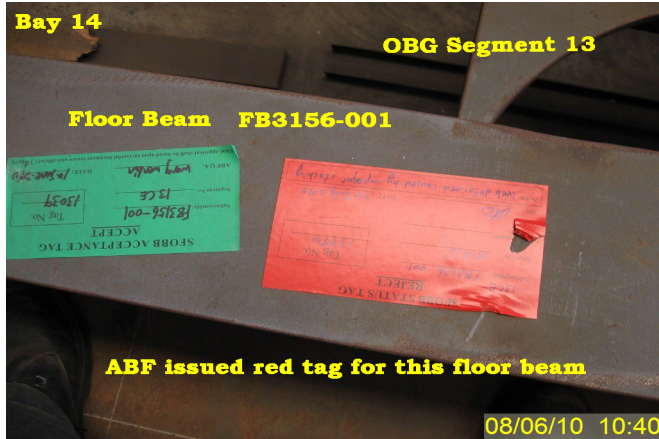
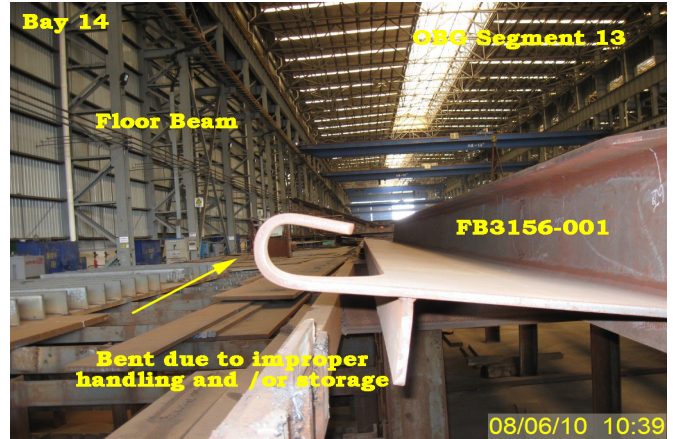
Description of Incident: During the Quality Assurance (QA) random in-process visual inspection this QA inspector observed Segment 13 Floor Beam components that appear to have been bent due to improper handling and /or storage. These Floor Beam components are identified as FB3132-001 and FB3156-001. The red tag numbers are identified as 13990 and 13991. These Floor Beam are located in the East side of Bay 14. For further information, please see the attached pictures below.
